2.0 Edgemont

Edgemont Site Long-Term Custody Compliance Requirements

Edgemont Site Inspection Results

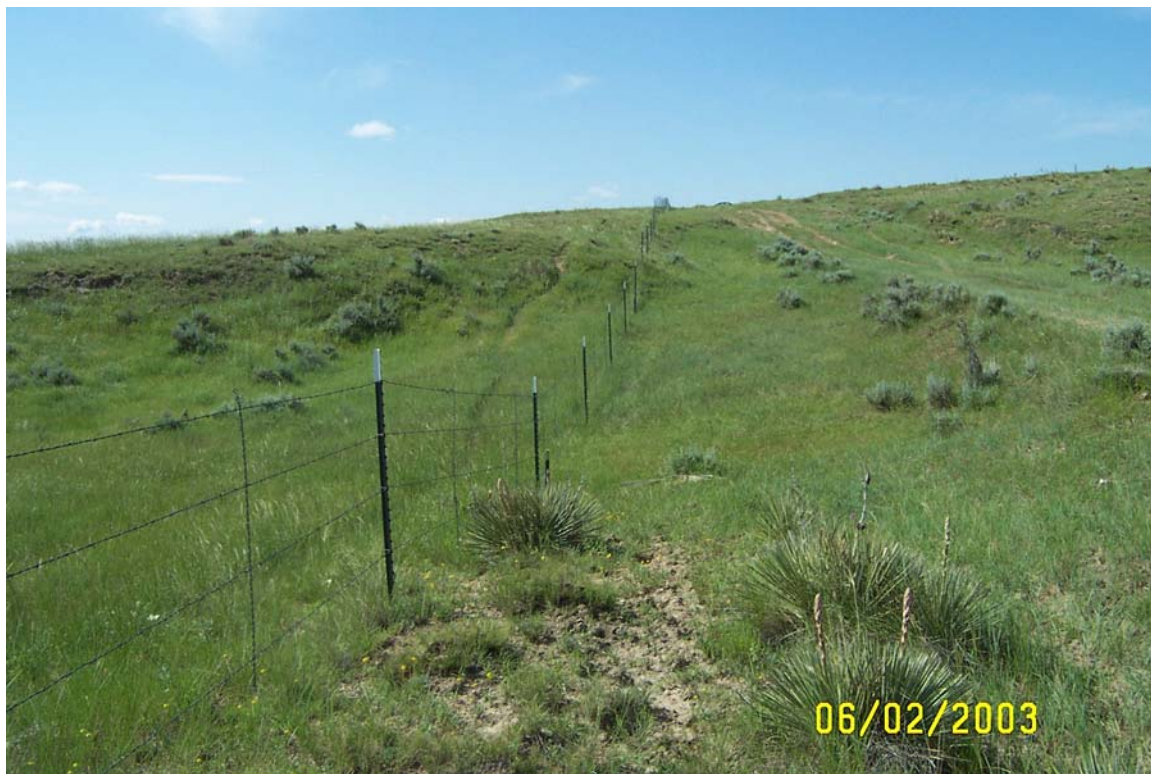
A four-strand barbed-wire fence was installed in spring 1999 along the site boundary to demarcate DOE property and to control grazing on the property. The entire fence line was walked to inspect the fence and the boundary monuments. Minor fence repairs, including tightening two strands of wire on the west boundary and reattaching wire to the t-posts, were conducted during the inspection. Based on the condition of the range inside the fence on site property versus outside the fence, the fence is adequately preventing unauthorized grazing. The fence is in excellent condition (PL-1).

EDG 6/2003. PL-1. Fence line on western property boundary. NOTE: Correct date of photo is 06/04/2003.

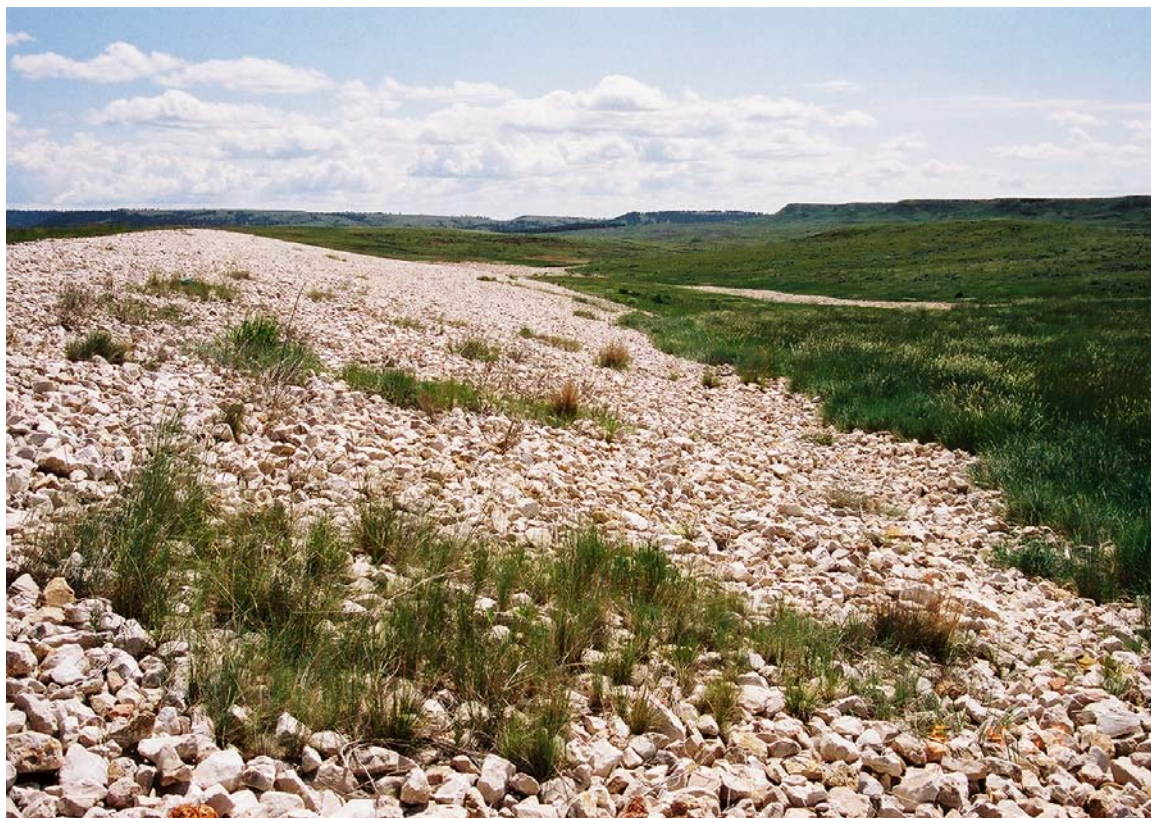
The tailings dam face, the steepest slope on site, is covered with riprap. The slope is stable and the riprap shows no signs of degradation. Scattered plants, mostly grass, grow in the riprap (PL-2). These plants do not pose an immediate threat to stability or function of this structure. The plant density has not increased over the last few years. Plant density in the riprap dam face will continue to be evaluated during future inspections.

EDG 6/2003. PL-2. Embankment face.

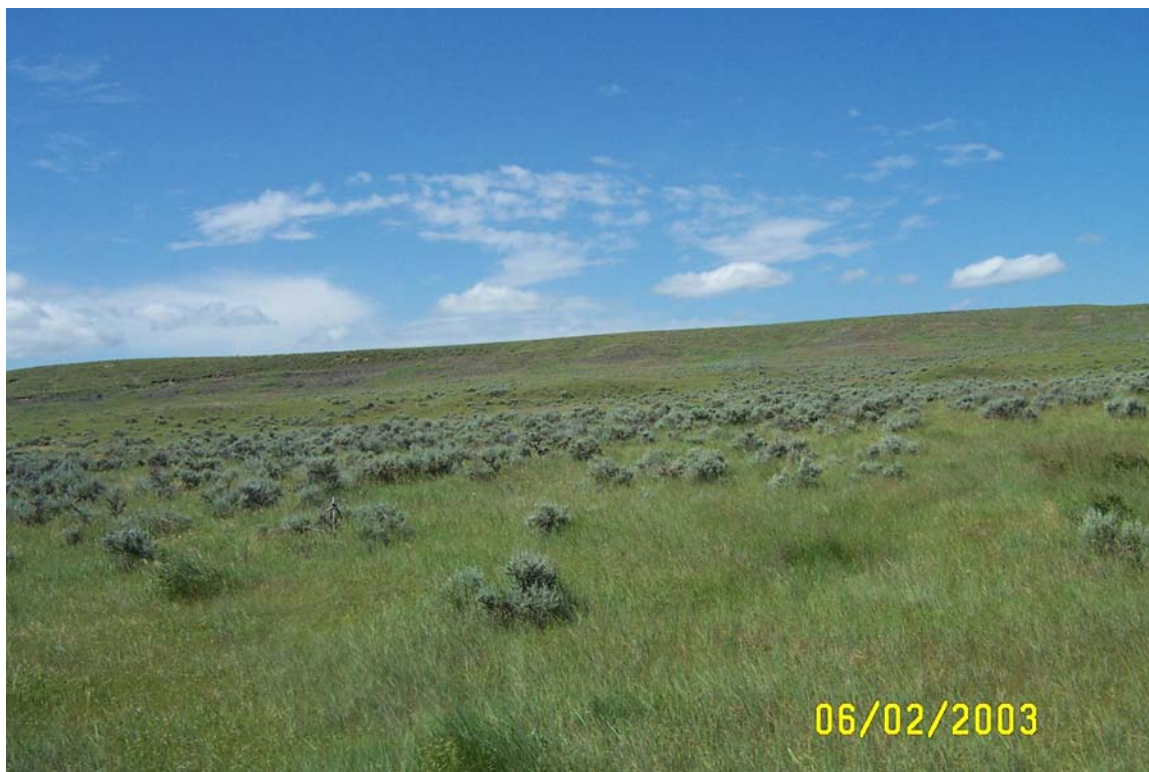
The area between the disposal cell and the site perimeter is grass-covered. This area is also grazed in a controlled manner. The grass is well established but minor erosion persists on steeper portions of the site east of the ridge that separates the northeast portion of the site property from the area containing the tailings cell (PL-3). This erosion does not threaten the integrity of the stabilized tailings.

EDG 6/2003. PL-3. View of steep bluffs from Boundary Monument 2. NOTE: Correct date of photo is 06/04/2003.
